**Flood Control Project Maintenance
Levee Inspections**

Fall 2011 Levee Maintenance Deficiency Summary Report

Reclamation District No. 2031 Elliot

Levee Inspection Report By Mile - Fall 2011

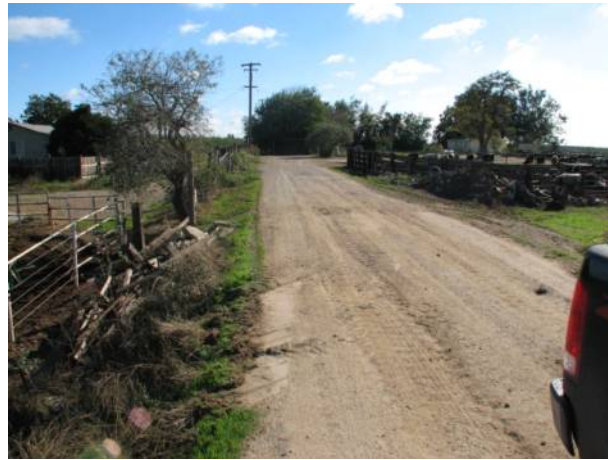
Levee Mile Report Line	1
Start Levee Mile	0.00
End Levee Mile	0.07
Location	Water Side
Category	Earthen Levee
Item	Encroachments

Fall 2009 photo looking upstream at beginning of unit 1. Water side to the left.

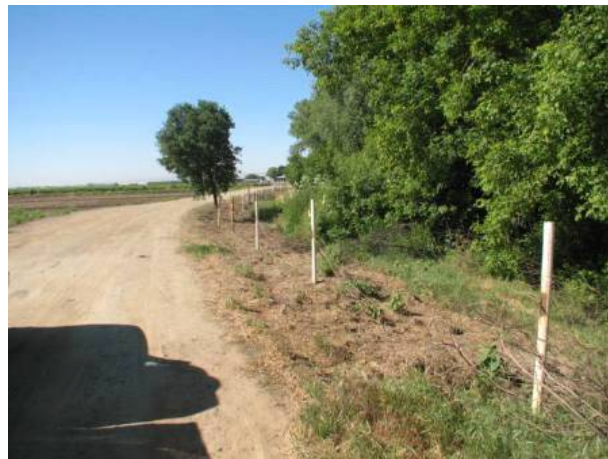
Levee Mile Report Line	3
Start Levee Mile	0.35
End Levee Mile	0.46
Location	Water Side
Category	Earthen Levee
Item	Encroachments

05/10/2011 Fence on waterside prevents access to waterside slope.

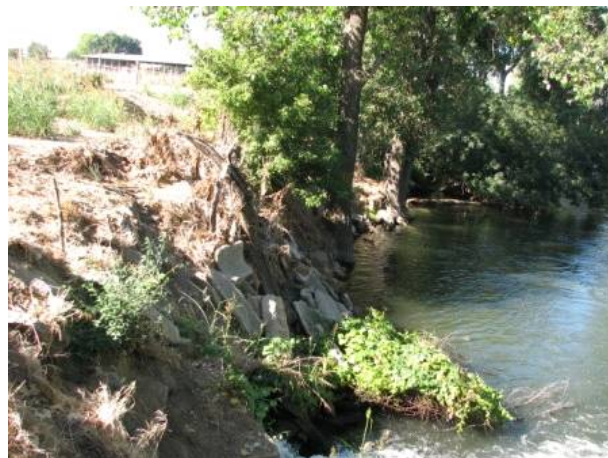
Levee Mile Report Line	4
Start Levee Mile	0.47
End Levee Mile	0.50
Location	Water Side
Category	Supplemental
Item	DWR Erosion Survey

Looking downstream of the site.

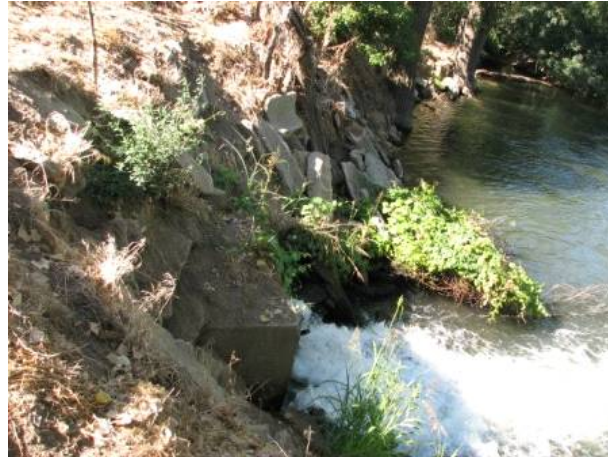
Levee Mile Report Line	4
Start Levee Mile	0.47
End Levee Mile	0.50
Location	Water Side
Category	Supplemental
Item	DWR Erosion Survey
Looking downstream of the site. The irrigation outlet operating. Debris at the outlet visible	
SJ2011_RD2031U01RM0.48_2.jpg

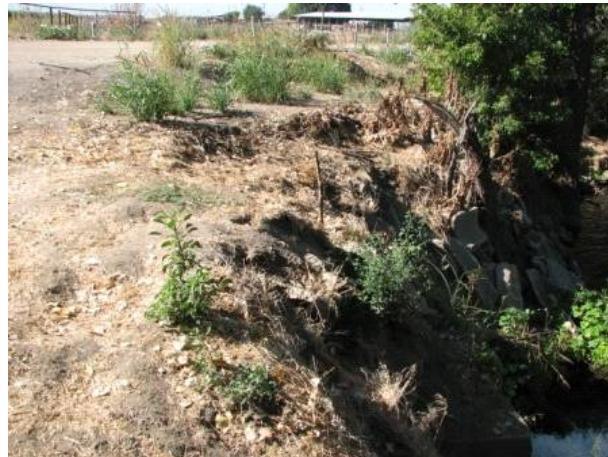
Levee Mile Report Line	4
Start Levee Mile	0.47
End Levee Mile	0.50
Location	Water Side
Category	Supplemental
Item	DWR Erosion Survey
View of the current condition of the levee slope just above the irrigation outlet.	
SJ2011_RD2031U01RM0.48_3.jpg

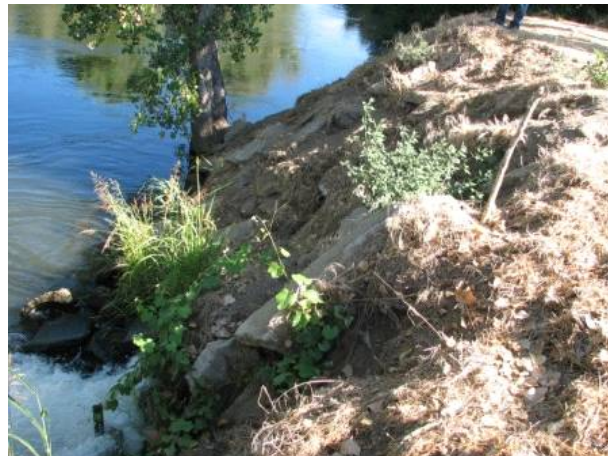
Levee Mile Report Line	4
Start Levee Mile	0.47
End Levee Mile	0.50
Location	Water Side
Category	Supplemental
Item	DWR Erosion Survey
Downstream view of the site.	
SJ2011_RD2031U01RM0.48_4.jpg

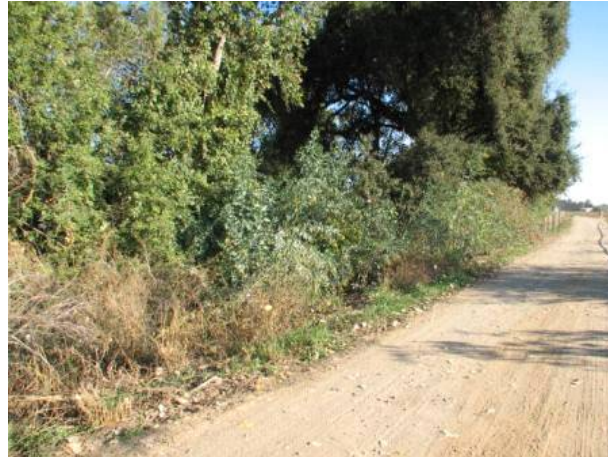
Levee Mile Report Line	5
Start Levee Mile	0.52
End Levee Mile	0.52
Location	Water Side
Category	Earthen Levee
Item	Vegetation
10/26/2011 Updated photo of waterside vegetation.	
jeto_f_20111104_513.jpg

5	0.52	0.52	Earthen Levee	Vegetation	WS	M	Remove the wild growth other than native grasses from the levee slopes.	37.704050 ° -121.159578 °	37.704050 ° -121.159578 °	2 Y
6	0.55	0.65	Earthen Levee	Encroachments	LS	CO	Buildings Inspector Comments: Corrals and house on levee slope and crown.	37.703626 ° -121.159714 °	37.702648 ° -121.160700 °	969 Y
7	0.64	0.71	Earthen Levee	Encroachments	LS	PO	Fences	37.702814 ° -121.160562 °	37.701875 ° -121.161670 °	4
8	0.64	0.64	Earthen Levee	Crown Surface / Depressions / Rutting	CR	M	Regrade the crown roadway for proper drainage.	37.702766 ° -121.160598 °	37.702766 ° -121.160598 °	970
9	0.75	0.78	Earthen Levee	Encroachments	LS	PO	Agricultural Ditch	37.701566 ° -121.161852 °	37.701178 ° -121.162086 °	972
10	0.81	0.81	Earthen Levee	Encroachments	LS	M	Pipe Inspector Comments: PVC pipe present and obstructing drain pipe.	37.700799 ° -121.162418 °	37.700799 ° -121.162418 °	20 Y

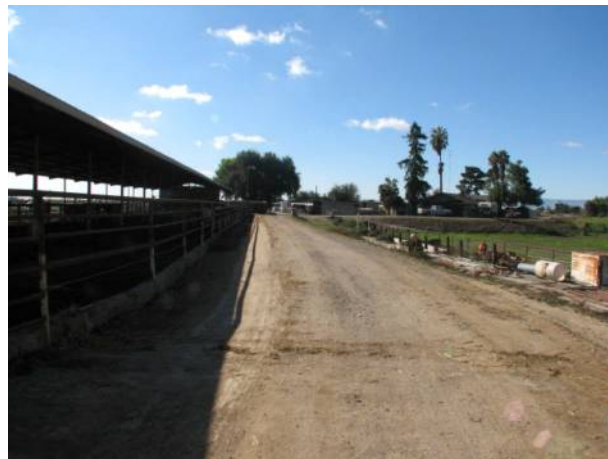
Levee Mile Report Line	6
Start Levee Mile	0.55
End Levee Mile	0.65
Location	Land Side
Category	Earthen Levee
Item	Encroachments
Fall 2009 photo of livestock pens and house on landside slope.	
jeto_f_20110923_119.jpg

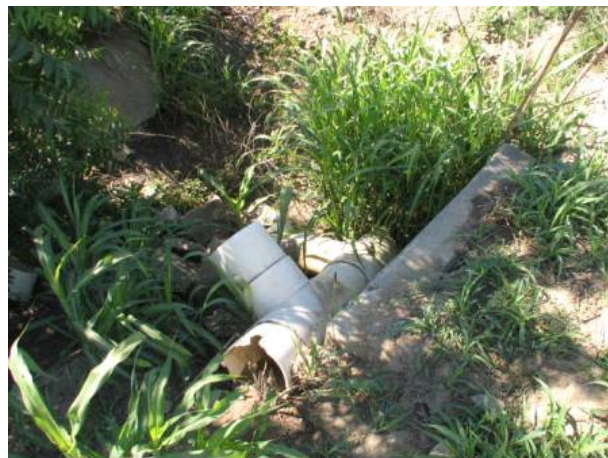
Levee Mile Report Line	10
Start Levee Mile	0.81
End Levee Mile	0.81
Location	Land Side
Category	Earthen Levee
Item	Encroachments
05/10/2011 PVC pipe pieces are obstructing opening to drain pipe.	
jeto_f_20110923_116.jpg

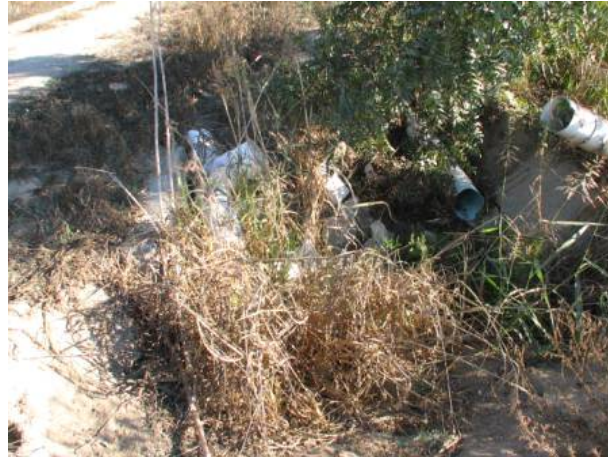
Levee Mile Report Line	10
Start Levee Mile	0.81
End Levee Mile	0.81
Location	Land Side
Category	Earthen Levee
Item	Encroachments
10/26/2011 Updated photo of PVC pipe pieces obstructing drain pipe, issue remains from Spring 2011 inspection.	
jeto_f_20111104_512.jpg

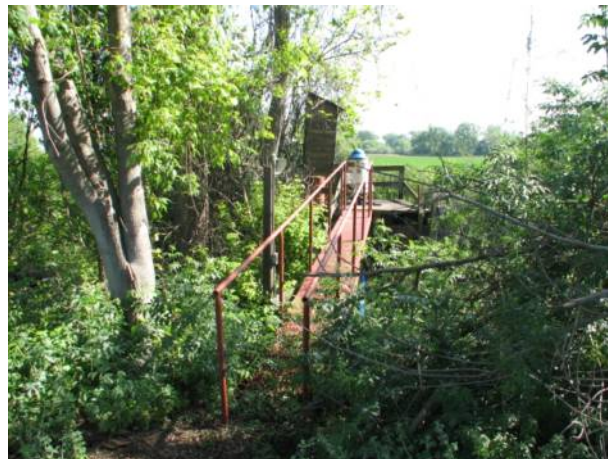
Levee Mile Report Line	12
Start Levee Mile	1.27
End Levee Mile	1.27
Location	Water Side
Category	Earthen Levee
Item	Encroachments
Irrigation intake pump and pipe.	
jeto_f_20110923_114.jpg

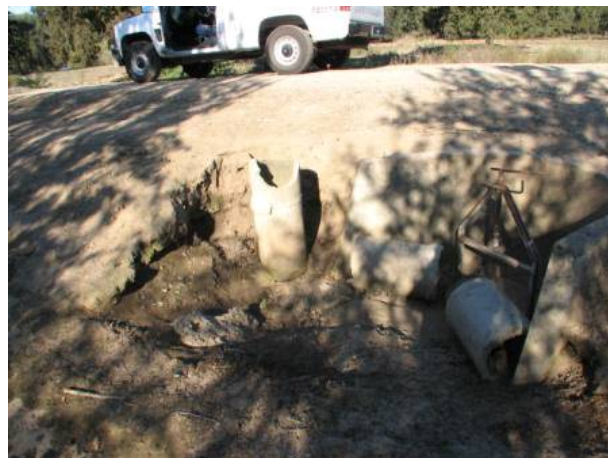
Levee Mile Report Line	14
Start Levee Mile	1.58
End Levee Mile	1.58
Location	Land Side
Category	Earthen Levee
Item	Erosion / Bank Caving
10/26/2011 Active erosion into the levee prism around irrigation standpipe.	
jeto_f_20111104_511.jpg

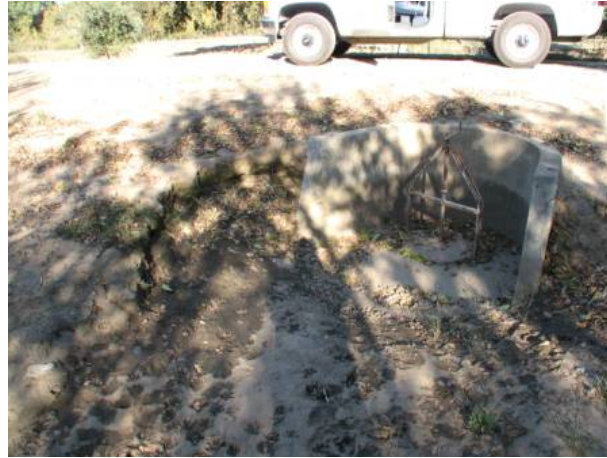
Levee Mile Report Line	15
Start Levee Mile	1.60
End Levee Mile	1.60
Location	Water Side
Category	Earthen Levee
Item	Erosion / Bank Caving
10/26/2011 Active erosion shown around irrigation inlet.	
jeto_f_20111104_510.jpg

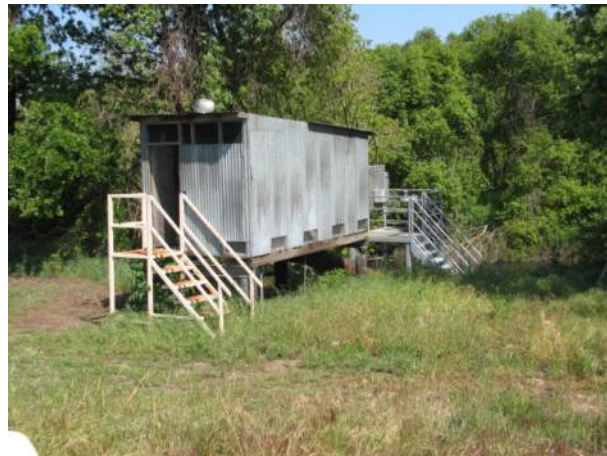
Levee Mile Report Line	24
Start Levee Mile	3.72
End Levee Mile	3.72
Location	Water Side
Category	Earthen Levee
Item	Encroachments
Irrigation intake on waterside berm.	
jeto_f_20110923_115.jpg

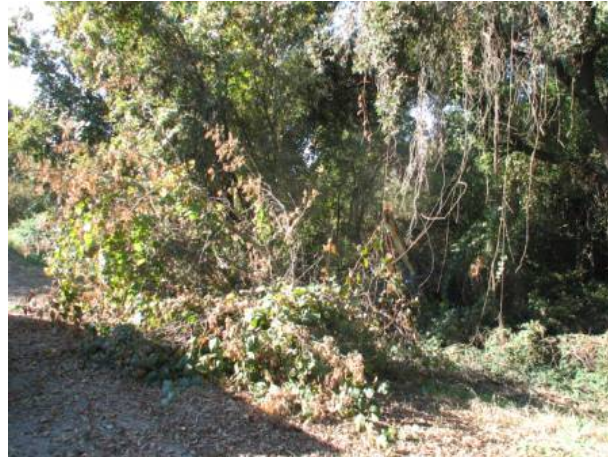
Levee Mile Report Line	29
Start Levee Mile	4.50
End Levee Mile	4.50
Location	Water Side
Category	Earthen Levee
Item	Trim / Thin Trees
10/26/2011 Fallen limb on waterside slope and crown.	
jeto_f_20111104_508.jpg

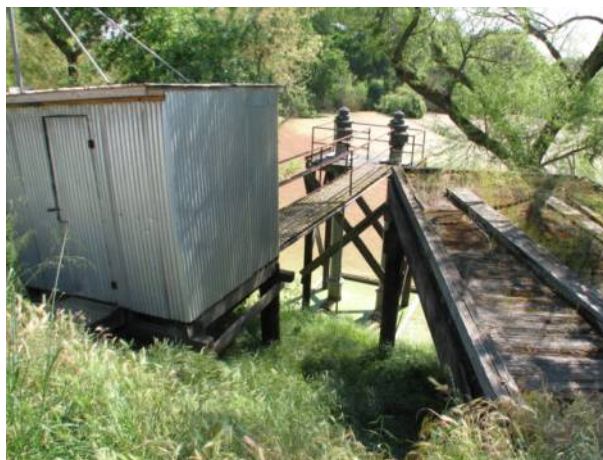
Drainage discharge pumps and housing on steep waterside slope.

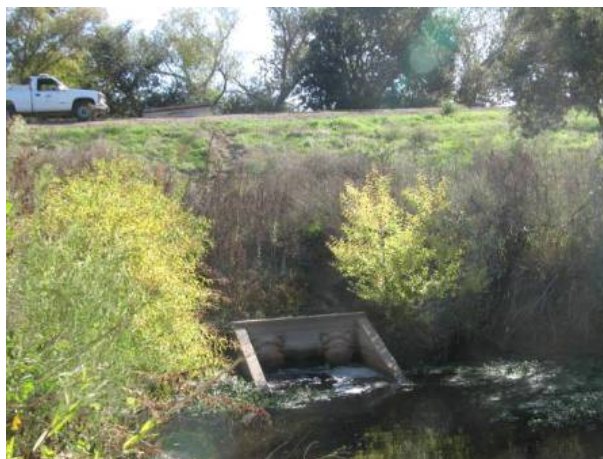
Levee Mile Report Line	1
Start Levee Mile	0.22
End Levee Mile	0.22
Location	Land Side
Category	Earthen Levee
Item	Encroachments

10/26/2011 Flap gates on landside.

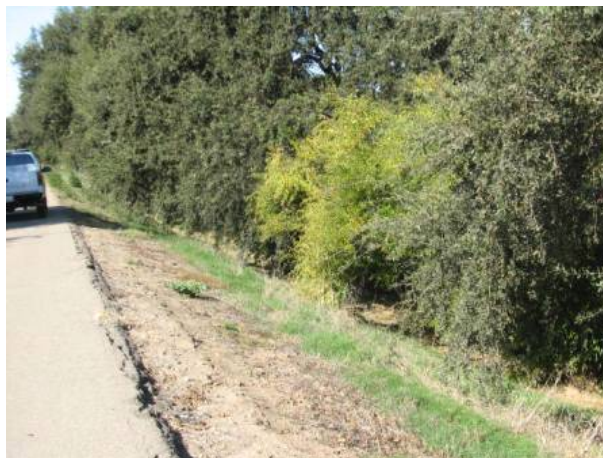
Levee Mile Report Line	2
Start Levee Mile	0.63
End Levee Mile	0.63
Location	Land Side
Category	Earthen Levee
Item	Trim / Thin Trees

10/26/2011 Trees on landside need to be trimmed up 5' above the ground to allow for visibility of the landside slope and toe.

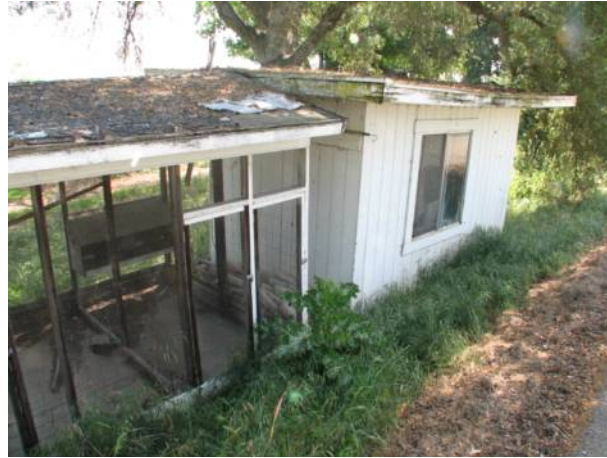
Small structure on levee slope.

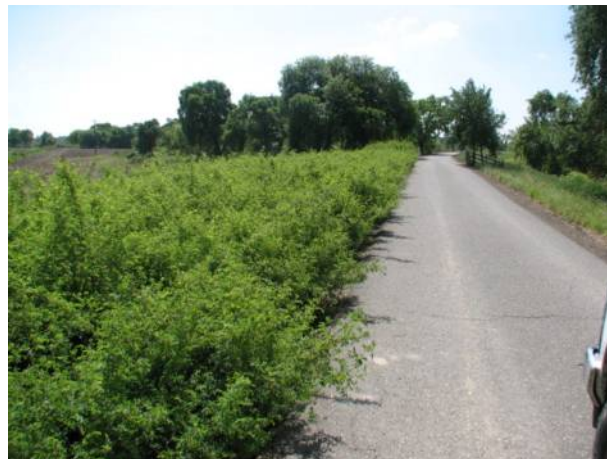
Levee Mile Report Line	5
Start Levee Mile	1.45
End Levee Mile	1.45
Location	Land Side
Category	Earthen Levee
Item	Encroachments

Wild rose on levee slope.

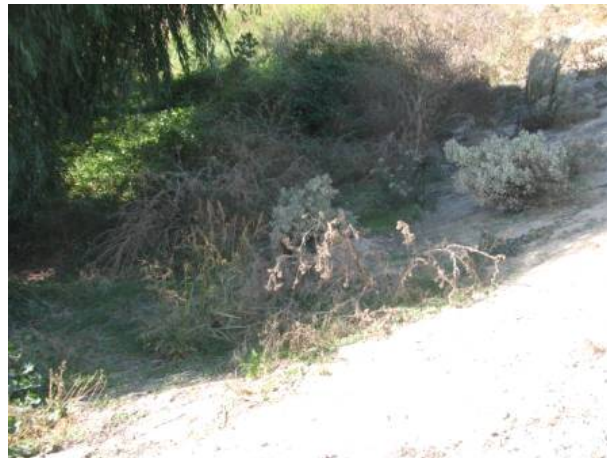
Levee Mile Report Line	8
Start Levee Mile	3.89
End Levee Mile	3.89
Location	Land Side
Category	Earthen Levee
Item	Vegetation

10/26/2011 Vegetation on landside obstructs visibility of the landside slope and toe.

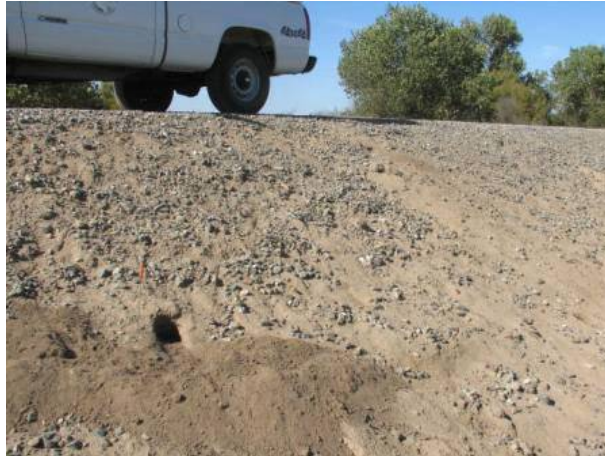
Levee Mile Report Line	9
Start Levee Mile	4.23
End Levee Mile	4.23
Location	Land Side
Category	Earthen Levee
Item	Animal Control
10/26/2011 Typical, burrow in area, several burrows at this location, many of them were flagged prior to the Spring 2011 inspection.	
jeto_f_20111107_517.jpg

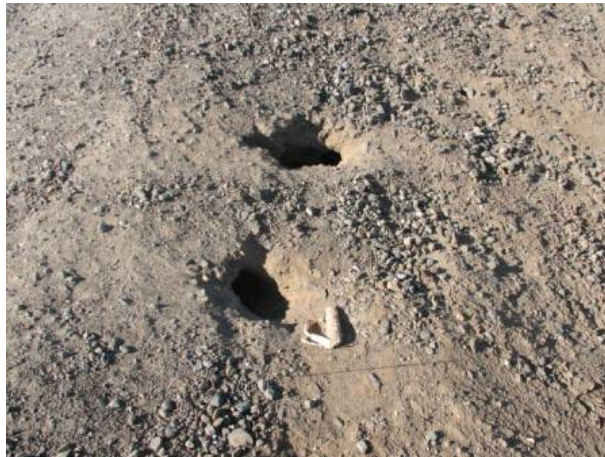
Levee Mile Report Line	10
Start Levee Mile	4.28
End Levee Mile	4.28
Location	Land Side
Category	Earthen Levee
Item	Animal Control
10/26/2011 Burrows that appear to be active, cleaned corn cob at entrance of one burrow.	
jeto_f_20111107_518.jpg

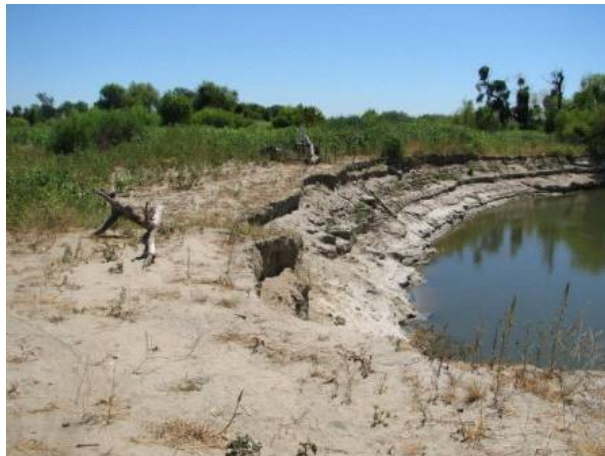
LMR No.	Levee Mile		Category	Item	Location *	Rating **	Action/Comment	GPS Latitude/Longitude		Issue No.
	Start	End						Start	End	
11	4.33	4.37	Supplemental	DWR Erosion Survey	WS	W	Inspector Comments: 08/18/2011: No significant changes observed on the site. Dead trees and animal activities visible. The closest point of the erosion site to the levee toe is about 100 ft. 10/19/2010: There is active scouring occurring on the bank due to the nature of the flow and the lack of armor protection. There is also a fallen log immediately downstream of where the erosion has occurred and is protruding outward, possibly creating an eddy and scouring the bank. With the remaining 100-foot wide berm, the levee prism is not yet affected. However, the bank will continue to degrade, and eventually intrude into the levee prism if no protection is put in place. Erosion site is recommended for annual assessment and monitoring during flood events. [2011 Site ID:RD2031U02RM78.7]	37.631716 ° -121.189370 °	37.631716 ° -121.189370 °	1 Y

Levee Mile Report Line	11
Start Levee Mile	4.33
End Levee Mile	4.37
Location	Water Side
Category	Supplemental
Item	DWR Erosion Survey
From the berm looking upstream. This the closest point to the levee toe.	
SJR2011_RD2031U02RM78.7_1.jpg

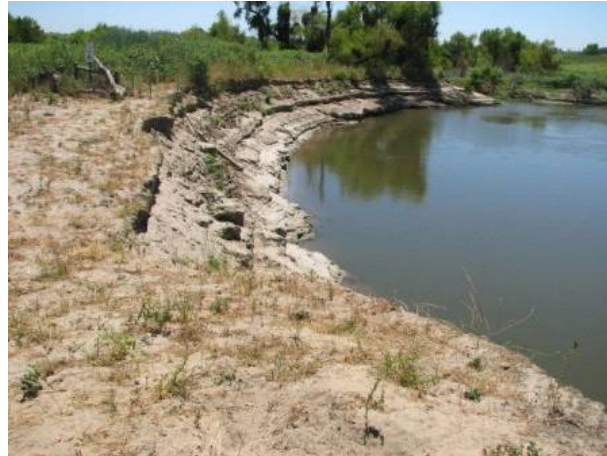
Upstream view of adjacent bank affected by erosion. The loose sand visible on the site.

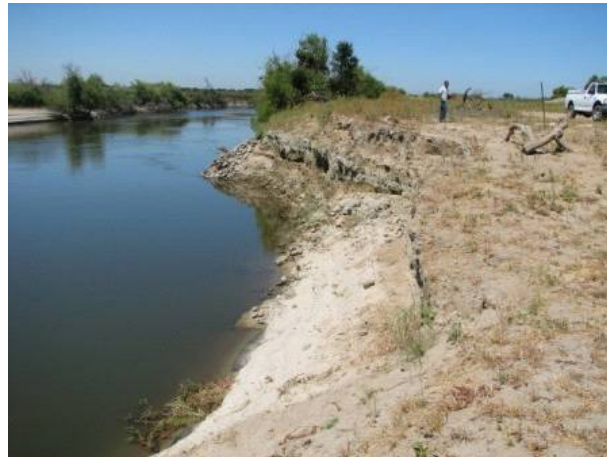
Levee Mile Report Line	11
Start Levee Mile	4.33
End Levee Mile	4.37
Location	Water Side
Category	Supplemental
Item	DWR Erosion Survey

Looking downstream. The starting point of the protection visible.

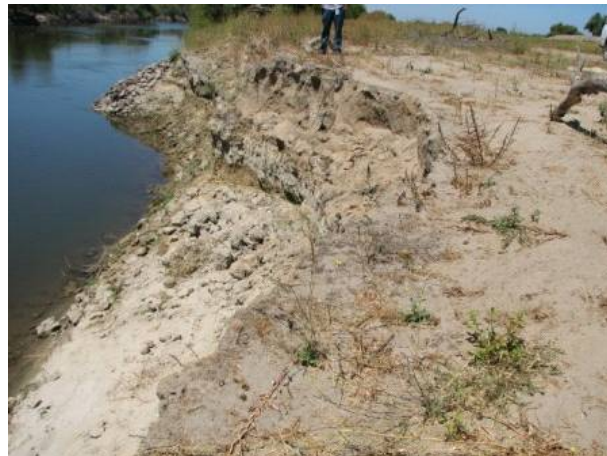
Levee Mile Report Line	11
Start Levee Mile	4.33
End Levee Mile	4.37
Location	Water Side
Category	Supplemental
Item	DWR Erosion Survey

A close look of the erosion. The loose sandy material visible.

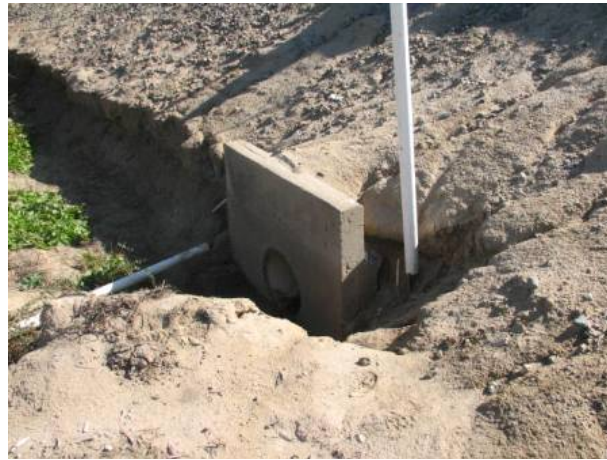
12	4.75	4.75	Earthen Levee	Encroachments	WS	W	Pipe Inspector Comments: 14" pipe through the levee concrete headwall on landside, waterside is submerged ditch. No gate on landside. This does not threaten the structural integrity of the levee, but it does appear to allow for the free flow of water through the levee.	37.630835 ° -121.182411 °	37.630835 ° -121.182411 °	12 Y
13	5.33	5.33	Earthen Levee	Animal Control	LS	U	No rodents visible, but rodent burrows visible; need to backfill and compact or grout burrows. Inspector Comments: This is a significant burrow with 3-5 cubic feet of fresh material present, There is a matching burrow on the water side, also with fresh material.	37.630799 ° -121.171802 °	37.630799 ° -121.171802 °	13 Y
14	5.46	5.46	Earthen Levee	Animal Control	LS	M	No rodents visible, but rodent burrows visible; need to backfill and compact or grout burrows. Inspector Comments: Multiple burrows, some appear to be active, others inactive.	37.630800 ° -121.169596 °	37.630800 ° -121.169596 °	14 Y

10/26/2011 Photo shows landside of 14" PVC pipe through levee. No flap gate or closure device observed.

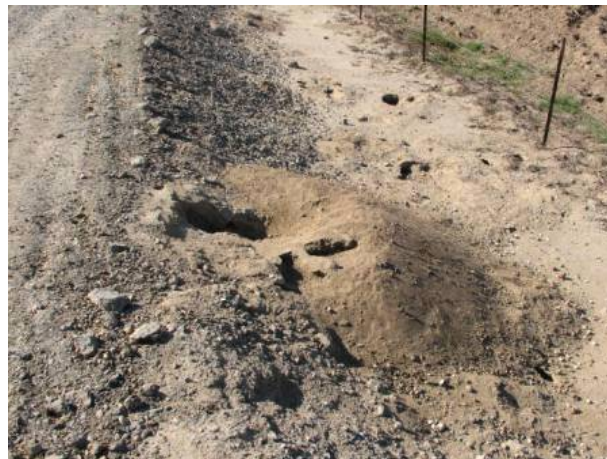
Levee Mile Report Line	13
Start Levee Mile	5.33
End Levee Mile	5.33
Location	Land Side
Category	Earthen Levee
Item	Animal Control

10/26/2011 Landside photo of large burrow, 3-5 cubic ft of material shown.

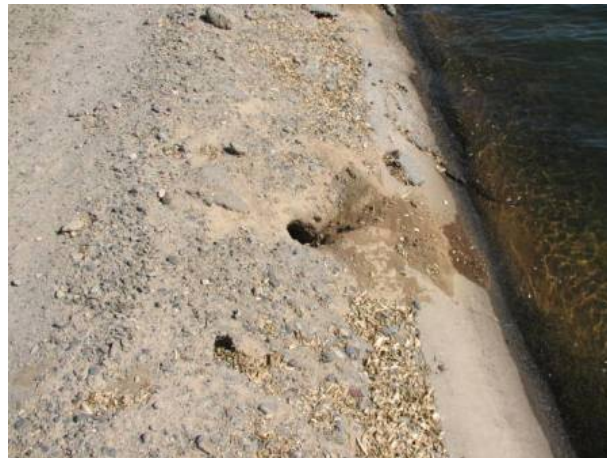
Levee Mile Report Line	13
Start Levee Mile	5.33
End Levee Mile	5.33
Location	Land Side
Category	Earthen Levee
Item	Animal Control

10/26/2011 Waterside burrow, located almost directly across from large burrow in previous photo. Note, material from burrow is being wetted by the canal water.

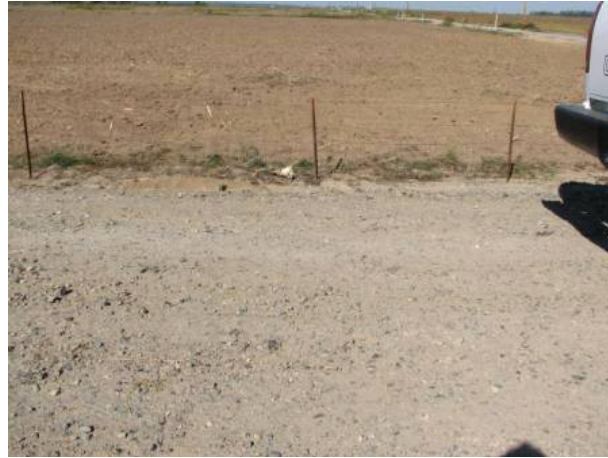
10/26/2011 Photo taken from location of waterside burrow to show relationship to landside burrow, which can be noted by fresh material seen over the levee crown approximately 2' to the left in this photo.

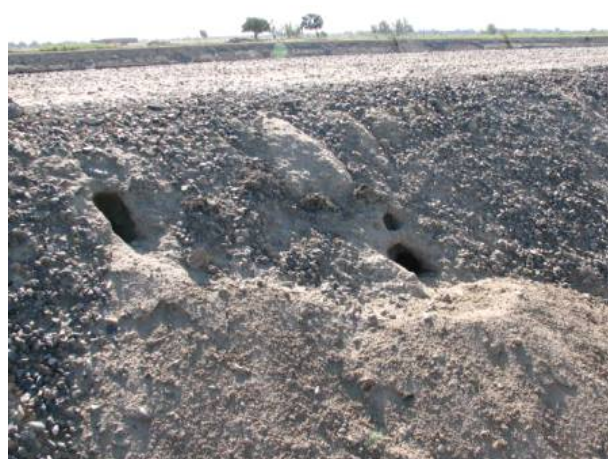
Levee Mile Report Line	14
Start Levee Mile	5.46
End Levee Mile	5.46
Location	Land Side
Category	Earthen Levee
Item	Animal Control

10/26/2011 Multiple burrows shown on the landside.

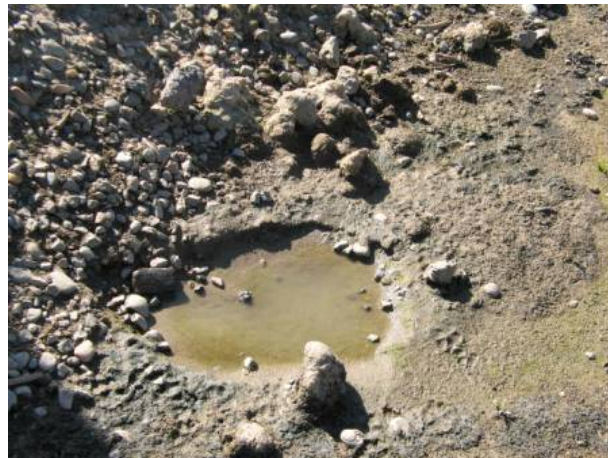
Levee Mile Report Line	15
Start Levee Mile	5.54
End Levee Mile	5.54
Location	Land Side
Category	Earthen Levee
Item	Seepage / Sandboils

15	5.54	5.54	Earthen Levee	Seepage / Sandboils	LS	U	Inspector Comments: 10/26/2011 Possible sand boil observed. Note that there is damage to the concrete channel directly across on the waterside of the levee from this issue. FIR filed for this issue, FIR no. 4422.	37.630797 ° -121.168204 °	37.630797 ° -121.168204 °	15 Y
16	5.65	5.65	Earthen Levee	Erosion / Bank Caving	LS	U	Inspector Comments: Active erosions occurring. Appears to be a hole behind the levee penetrating into the prism. Cracks observed above the hole on the levee slope. The waterside of the levee is a concrete lined MID irrigation canal.	37.630794 ° -121.166179 °	37.630794 ° -121.166179 °	16 Y

10/26/2011 First of three photos showing possible sand boil, appears to be a deposition of material as evidenced by the shadows on the upper side of the boil.

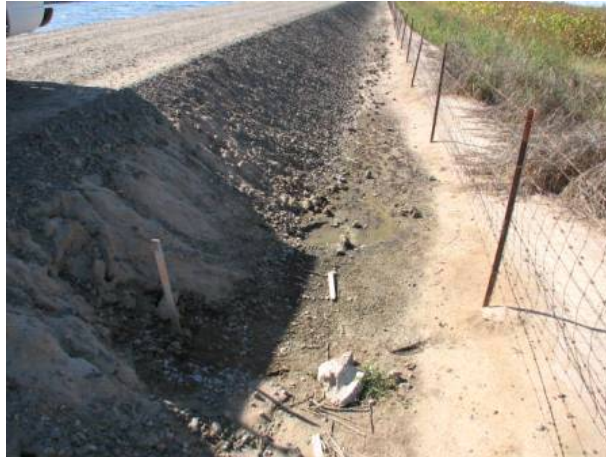
Levee Mile Report Line	15
Start Levee Mile	5.54
End Levee Mile	5.54
Location	Land Side
Category	Earthen Levee
Item	Seepage / Sandboils
10/26/2011 Photo shows location of boil relative to the levee.	
jeto_f_20111107_525.jpg

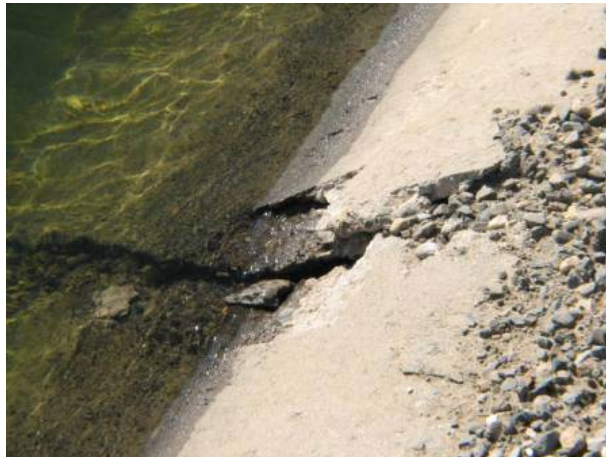
Levee Mile Report Line	15
Start Levee Mile	5.54
End Levee Mile	5.54
Location	Land Side
Category	Earthen Levee
Item	Seepage / Sandboils
10/26/2011 This concrete damage is located directly across the levee crown from the boil location.	
jeto_f_20111107_526.jpg

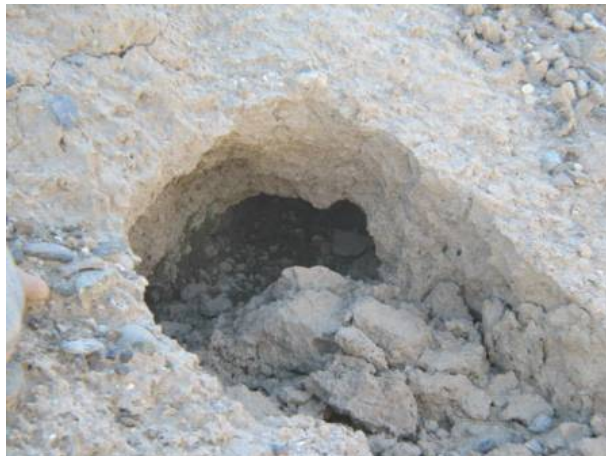
Levee Mile Report Line	16
Start Levee Mile	5.65
End Levee Mile	5.65
Location	Land Side
Category	Earthen Levee
Item	Erosion / Bank Caving
10/23/2011 Erosion located on the landside of the levee. Cracking above the hole in the levee slope and hole extends into the levee prism.	
jeto_f_20111107_527.jpg
